Thule Air Base Airfield White Painting and Permafrost Investigation

Phases I–IV

June 2013

Final report

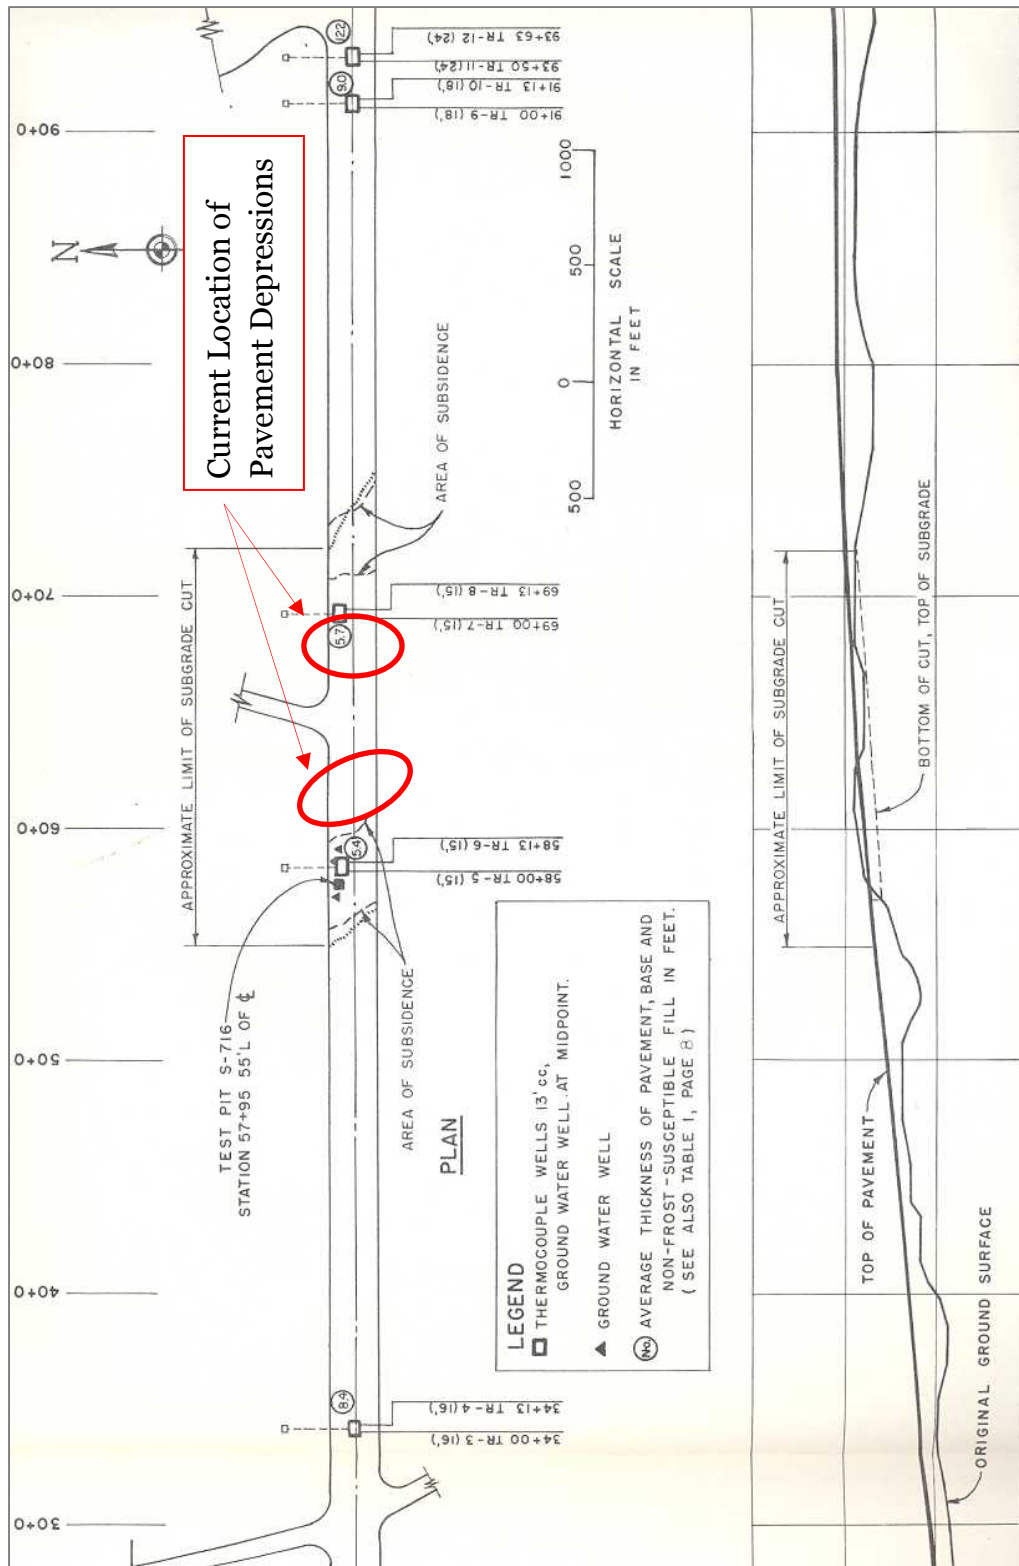
Figure 8. Plan view of depressions and test pits from ACFEL 1955 investigation (ACFEL 1955). Current depression areas are noted.

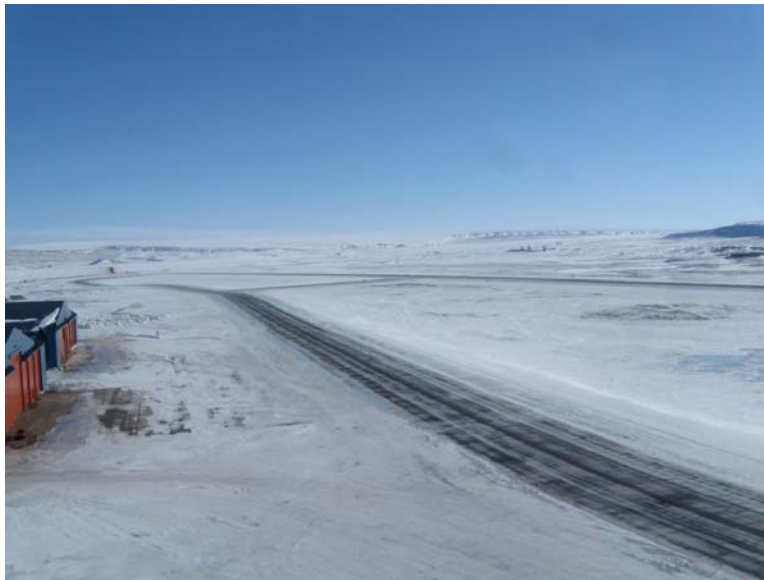
Figure 15. View from the tower April 2011, looking east to the 26 end of the runway. The faded and dark nature of the paint is very evident against the backdrop of white snow.

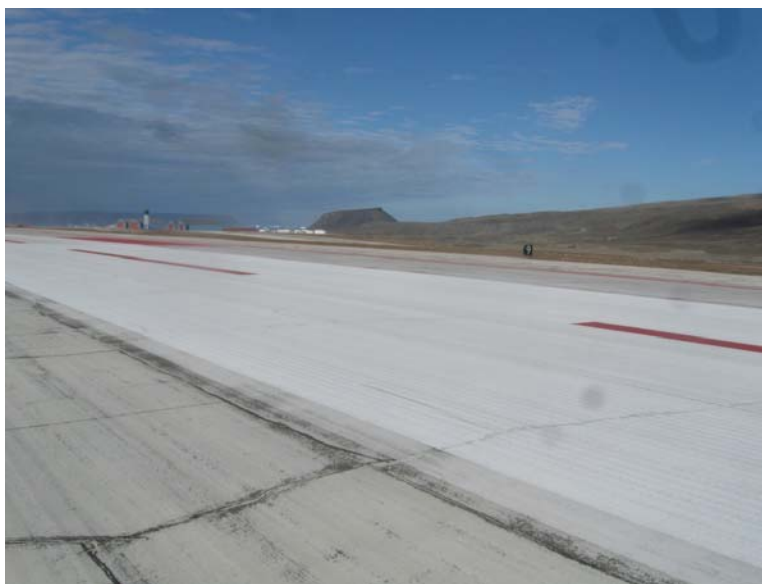
Figure 20. Bright white runway at 91+00. Albedo measured at 0.58 and the thaw depth measured at 3.9 ft.
